**ENGINEERING GEOLOGICAL CONTROLS ON FAILURE
MECHANISMS IN ROCK CUT-SLOPES IN THE TORLESSE
COMPOSITE TERRANE IN WELLINGTON, NZ**

Master of Science in Engineering Geology

University of Canterbury

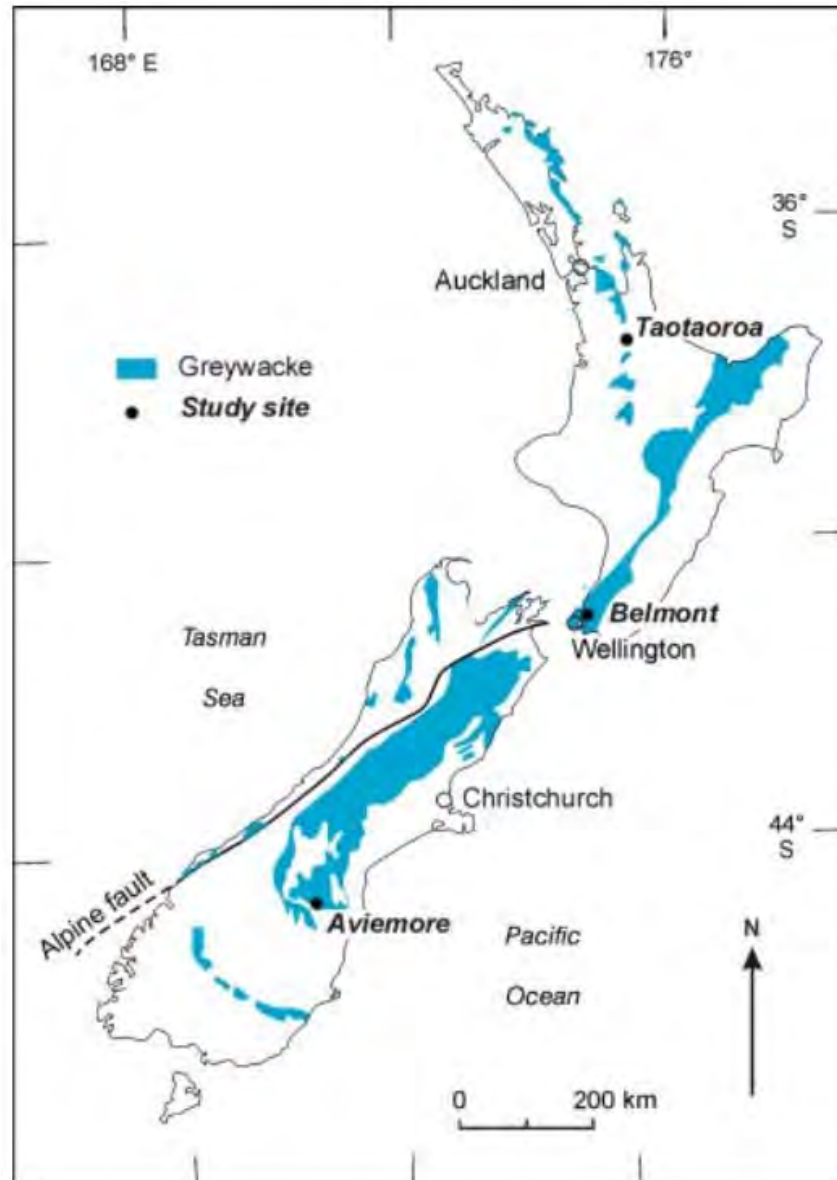
Figure 1.1: Extent of the New Zealand's Torlesse Composite terrane (Read et al., 2000).

The Torlesse Composite Terrane is a widespread geological unit encountered in rock cuttings along the national road network in New Zealand (Figure 1.1). It consists of a large group of rocks

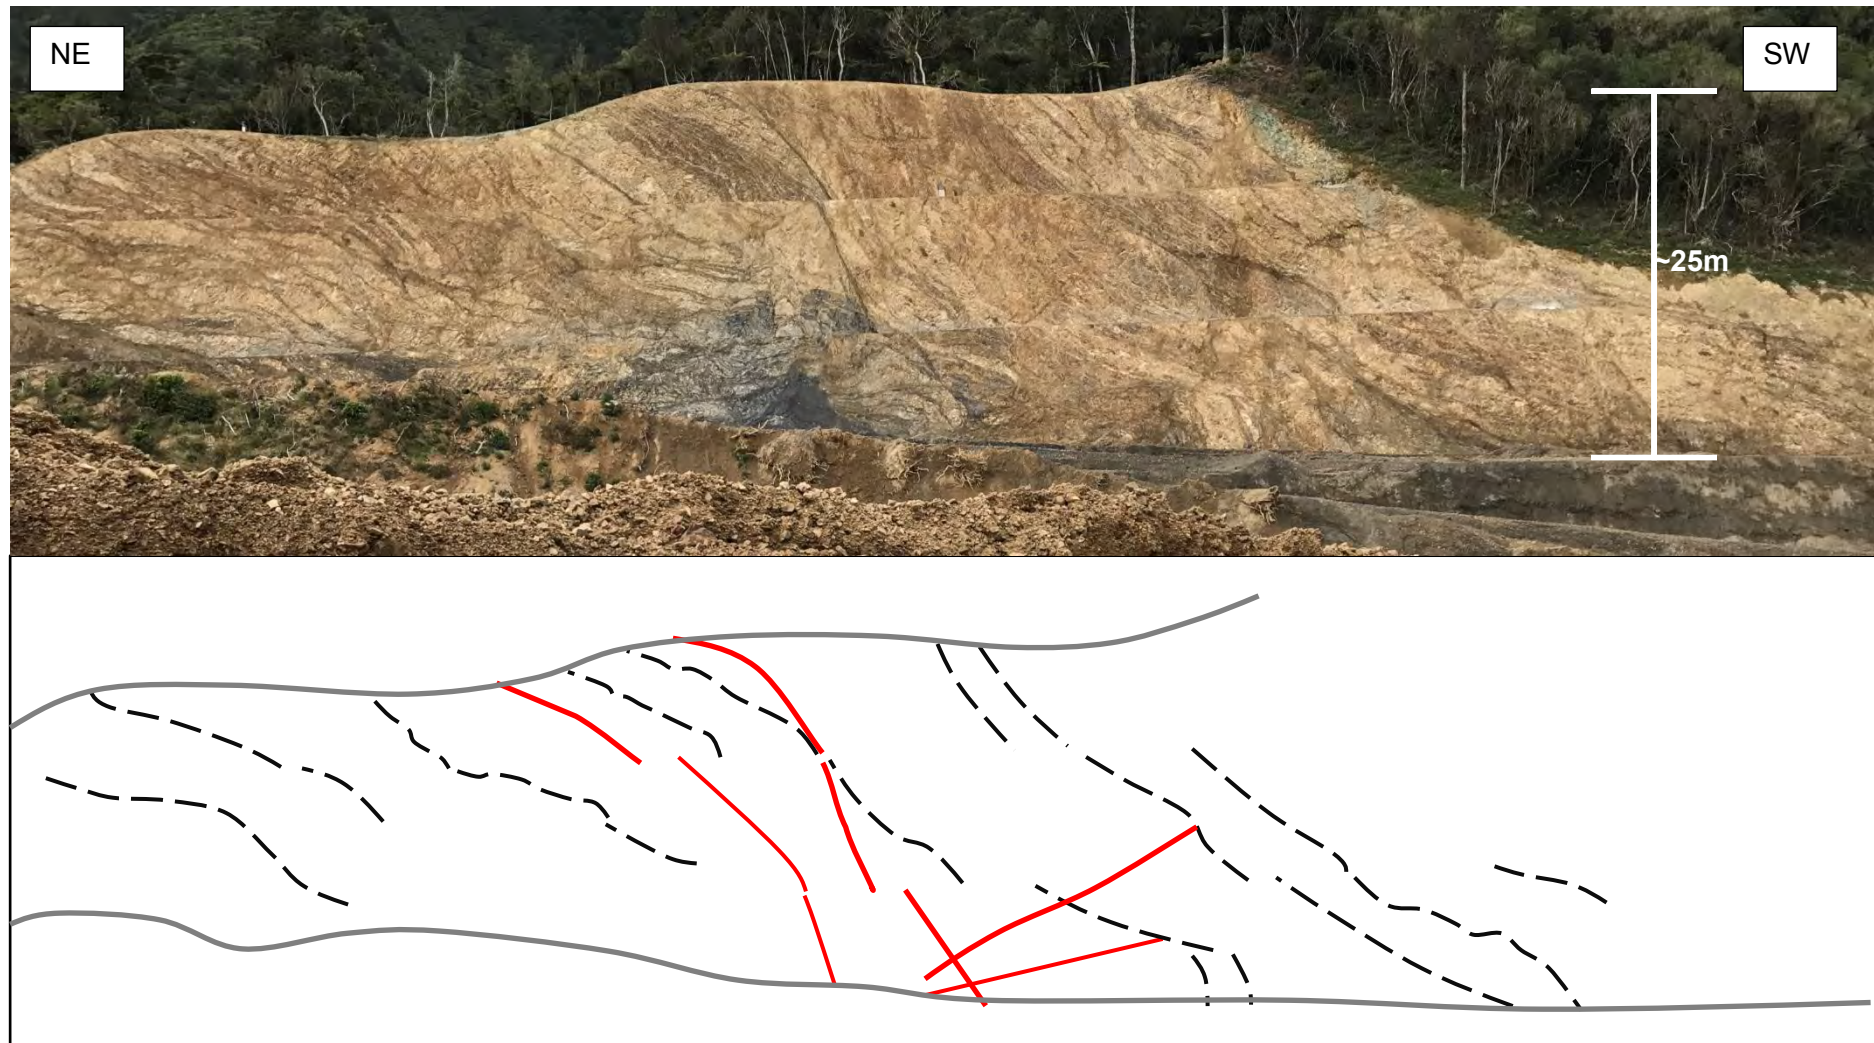
Figure 3.3: Photograph and sketch of a major cut in the Transmission Gully North study site. Photo taken 20th of March 2018 before shotcrete and other remedial measures were used to stabilise the darker fault crush material. The black dashed lines show bedding. The red are faults.

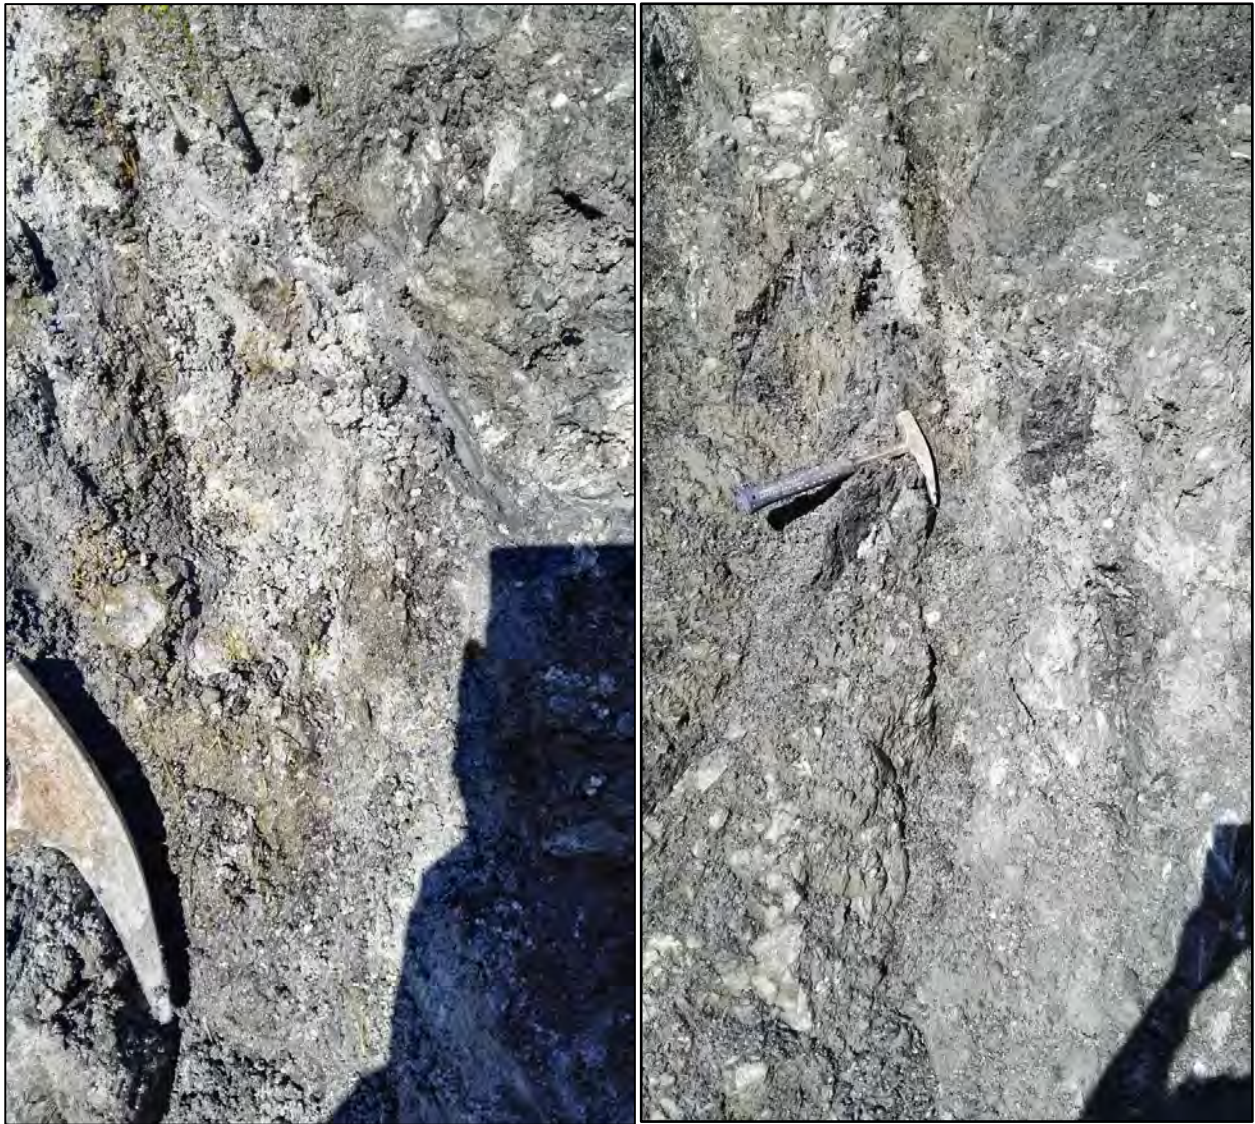
Figure 3.23: Fault crush material present on the lower bench on the south west corner of Kapiti Quarry. Hammer for scale, ~0.3 m.

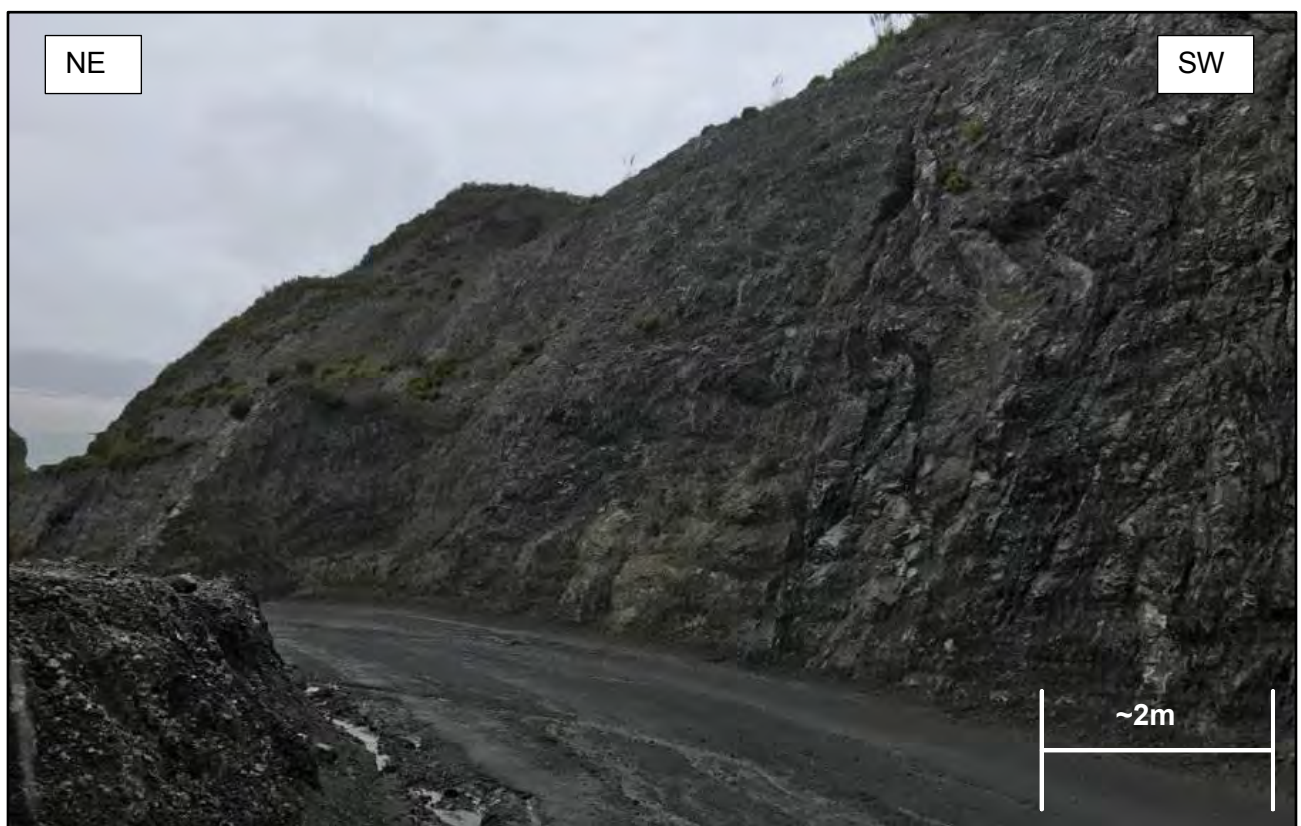
Figure 3.26: Exposure of Fault disturbed rock mass in Horokiwi Quarry. Located near the Wellington Fault, in the south study area.

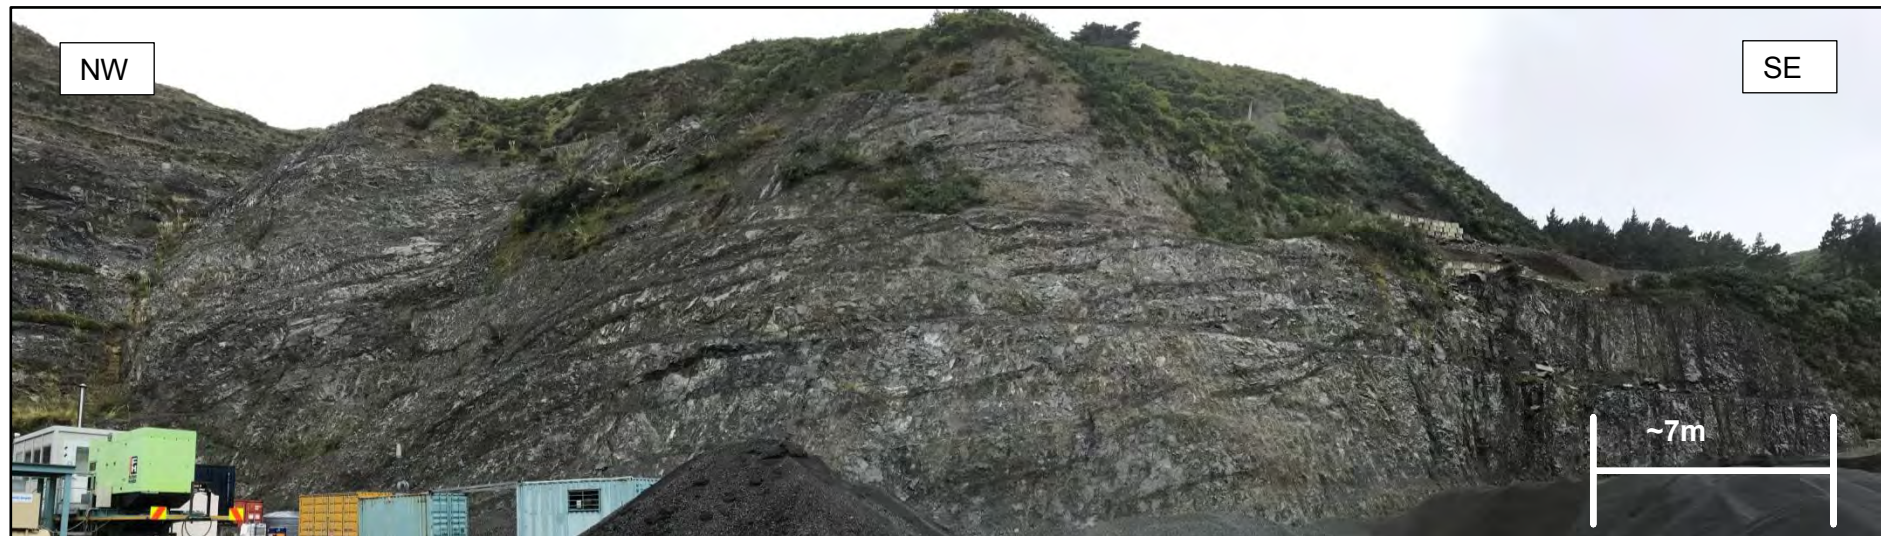
Figure 3.28: North study area in Horokiwi Quarry displaying “truncated” and continuous bedding in the “Margin Zone” area.

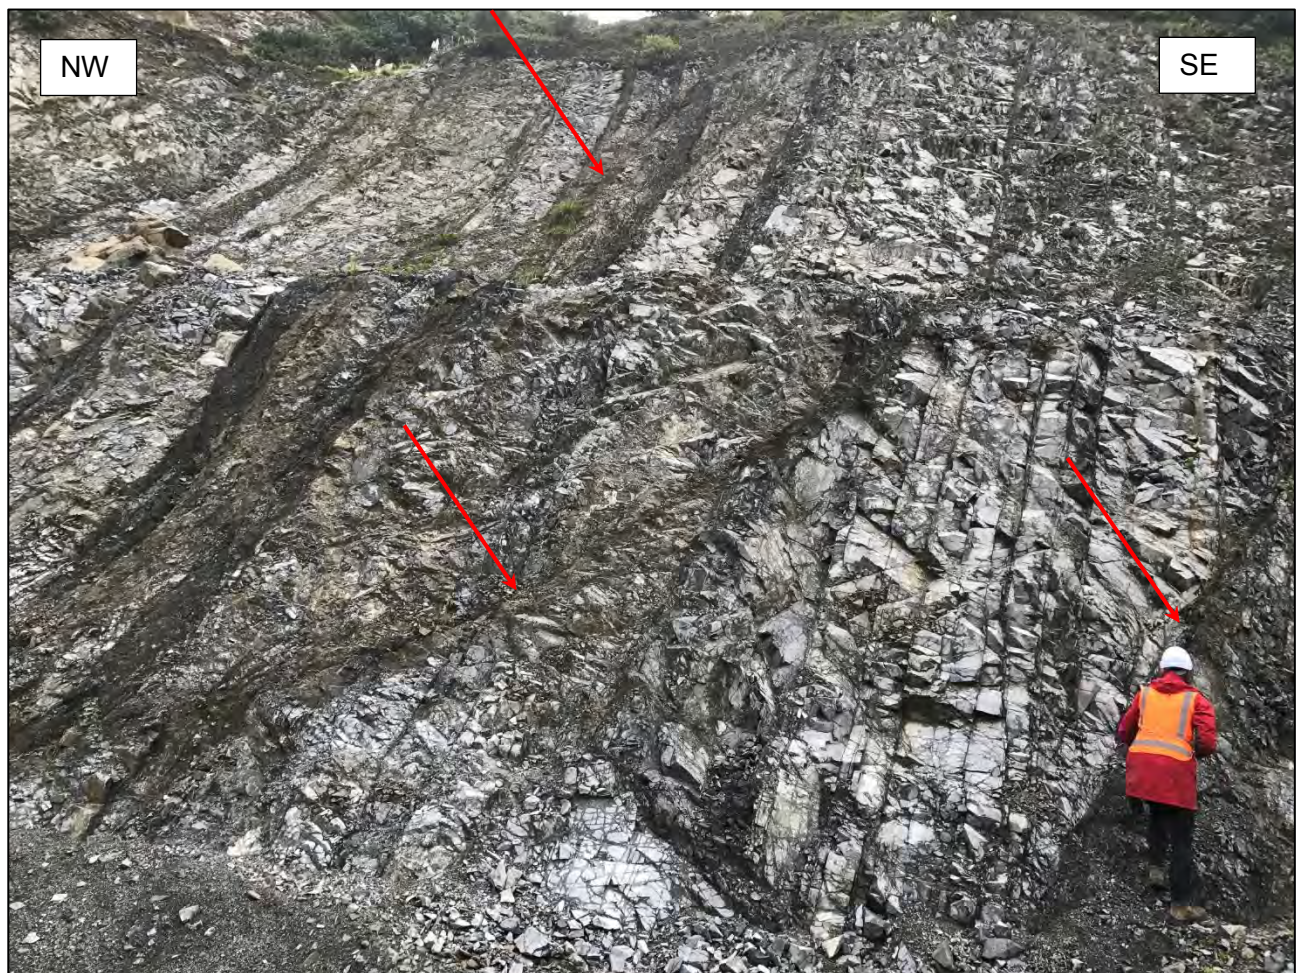
Figure 3.29: Displaying Margin Zone very widely spaced shearing forming conjugate (red arrow) to bedding.

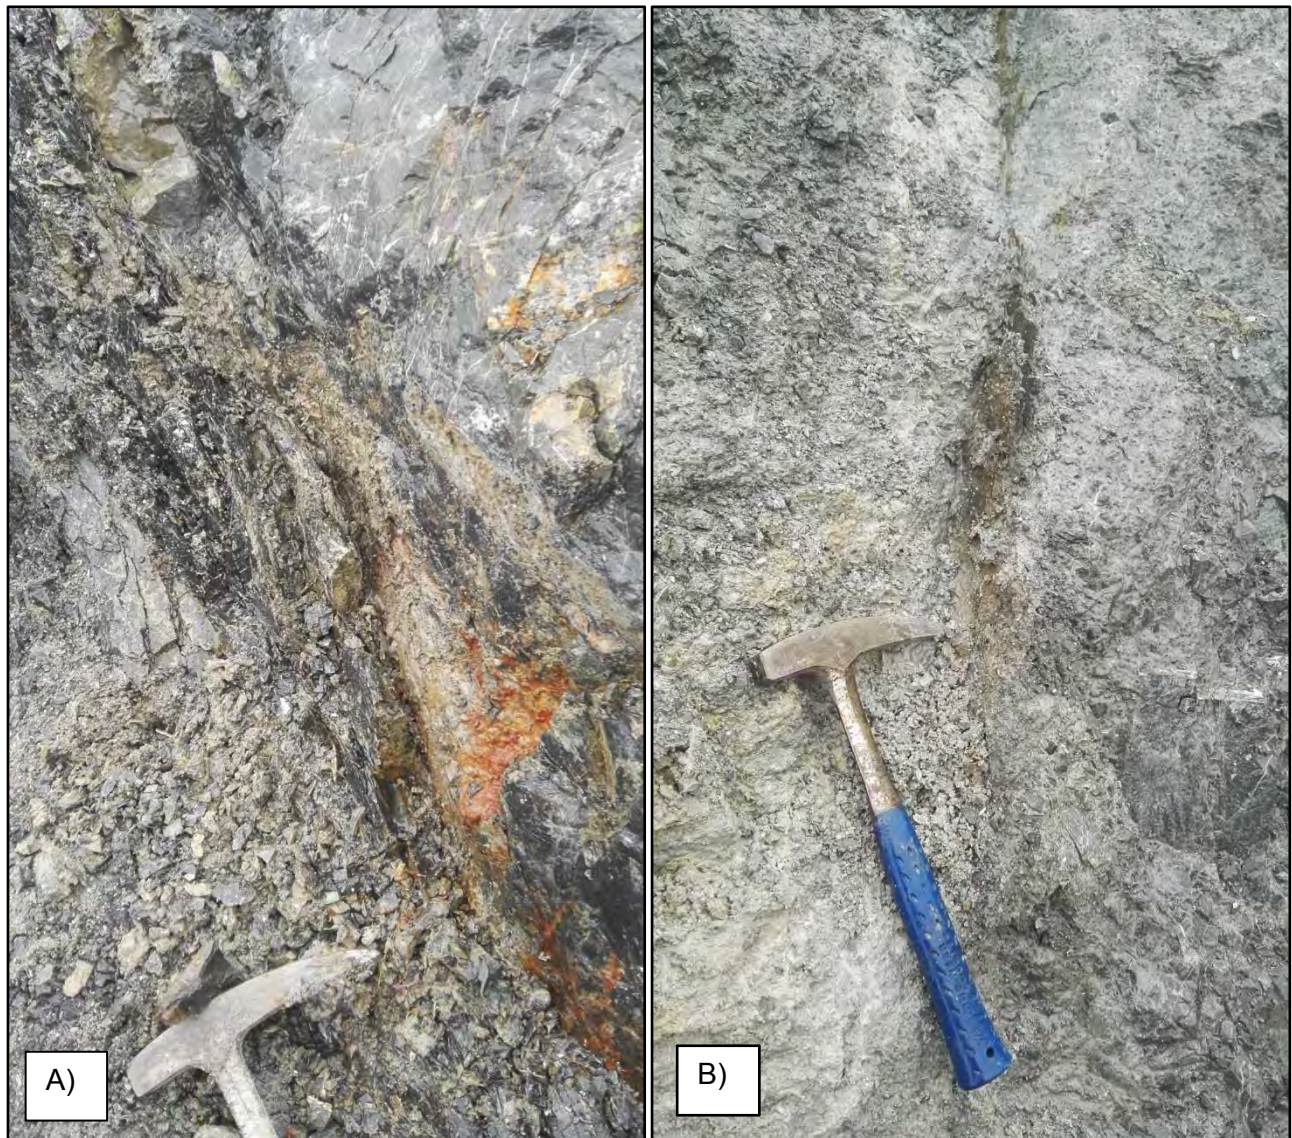
Figure 3.33: A) Photograph of a Bedding shear and B) a Shear zone in "Margin fault" zone material. Geological hammer is provided for scale, ~0.3 m long.

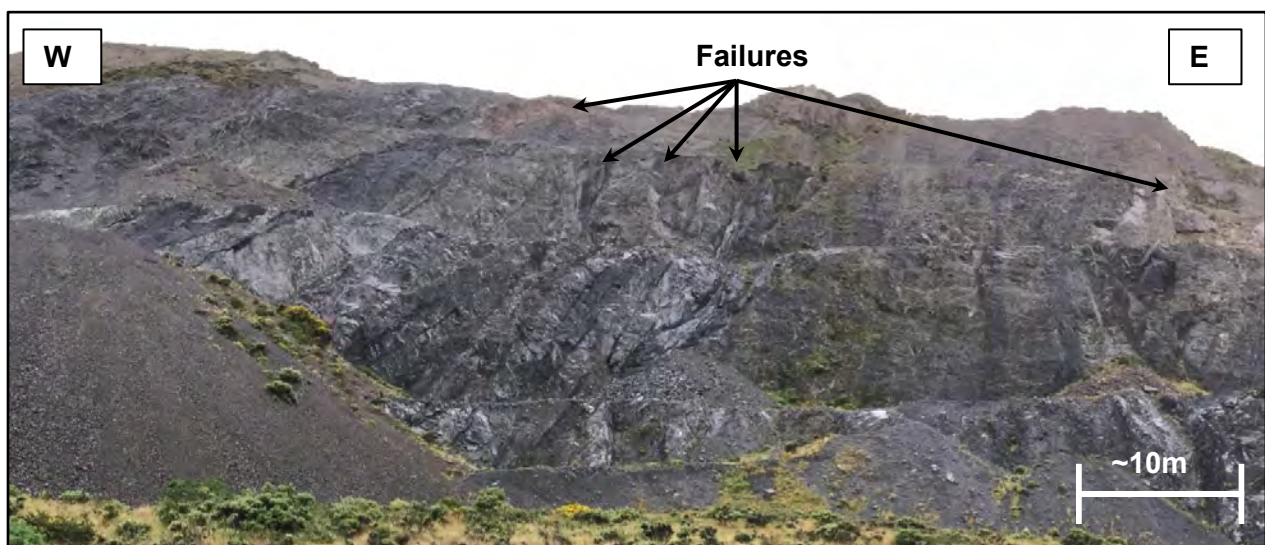
Figure 3.35: Shows a range of different rock mass conditions exposed in Owhiro Bay Quarry. Intersecting faulting and bedding defects form a number of failures in the upper benches.

Figure 3.35 and 3.36 displays a number of local and global failures occurring on the upper benches of the quarry. Important to note is that there appears to be a set of wedge failures evenly spaced out ($\sim 8 \text{ m}$) on the third bench up from the bottom (Figure 3.35). These failures all appear to fail locally on the intersection of bedding and continuous shears. Global failures appear to be commonly controlled by continuous faulting and bedding.

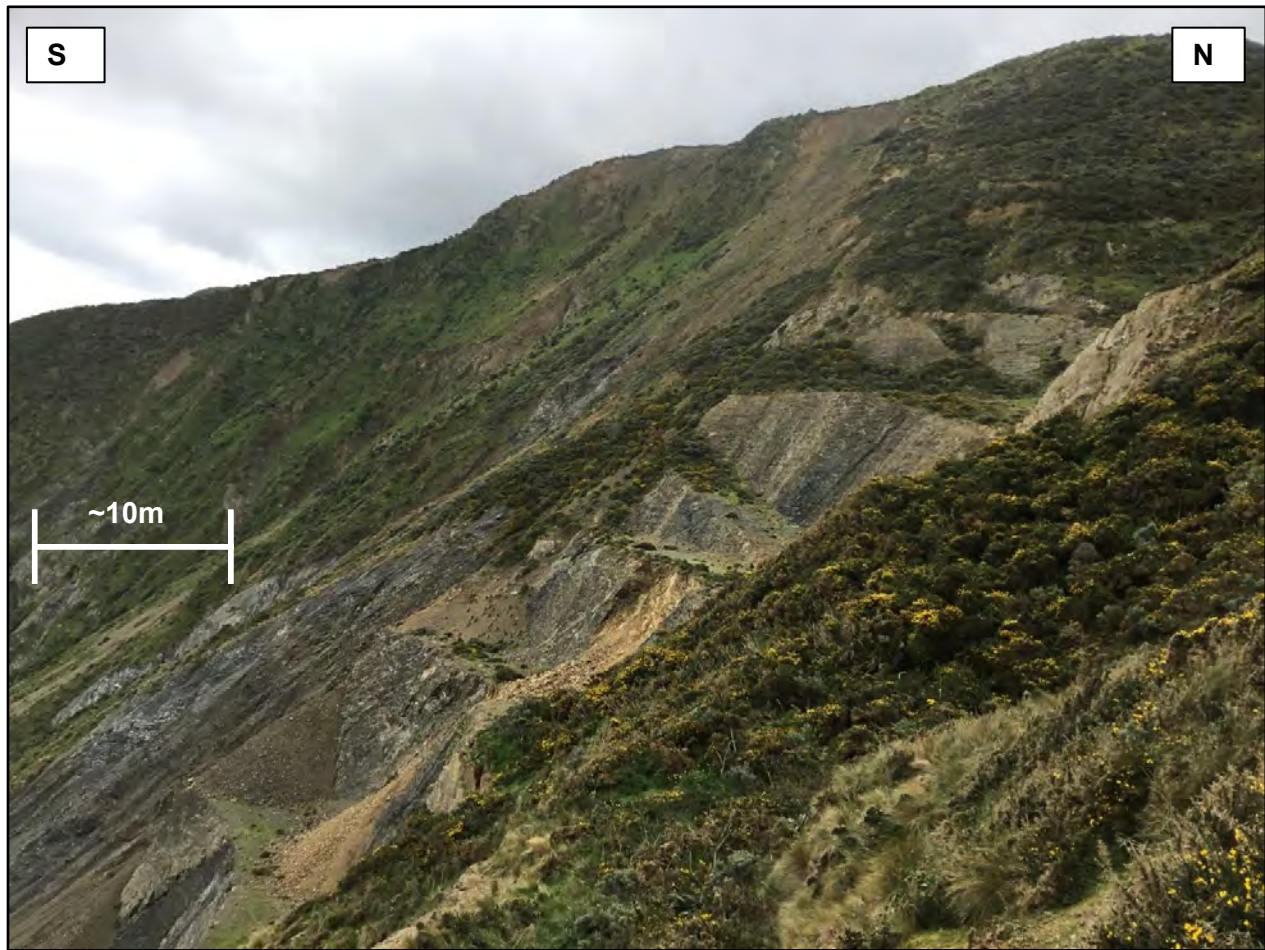
Figure 3.36: Failure in the upper benches of Owhiro Bay Quarry. Appears to be bedding and fault controlled in a thick mudstone rich bed.

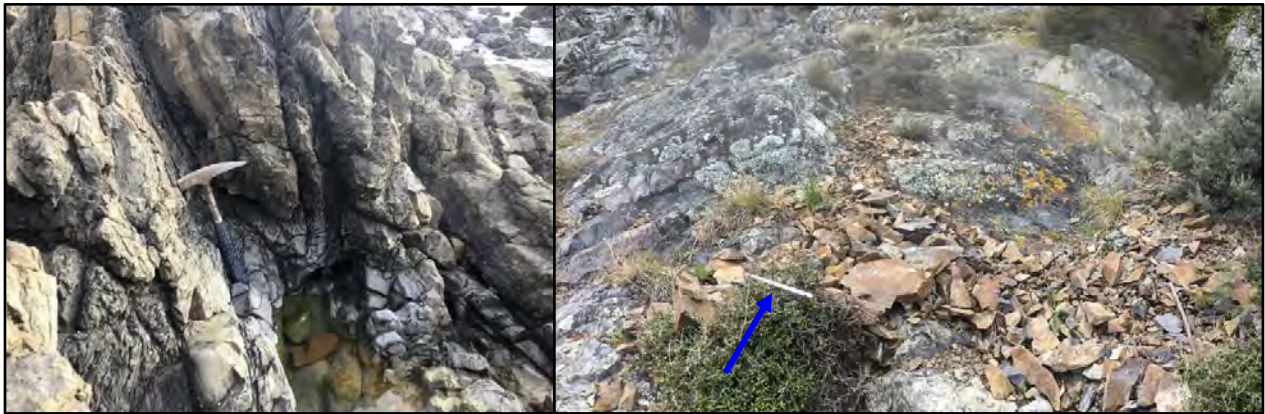
Figure 3.43: Folding observed at Wairaka Point. Left) observes tight to isoclinal inter-limb angles of first generation folding seen on shorelines while, Right) observes second generation folding which is more open. Geological Hammer and apple pencil are used for scale, approximately 0.3 m and 0.15 m respectively.

This site also displays a wide scale of folding. Figure 3.43 shows first and second generation folding at this site. Hinge lines of third generation folds are not observed. First generation folding tends to trend roughly northeast-southwest, while second generation folding tends to be oriented northwest-southeast. The second generation folding is indirectly associated with the previously mentioned global failure. The moderately inclined and northwest moderately plunging fold axis is unfavourable oriented. This results in an increased susceptibility for slope failure. This fold is interpreted to be an open anticlinal box fold. Tighter folding appears to occur in higher mudstone content areas and is typically of the first generation. Folding is only observed where the alternating sandstone to mudstone sequences is exposed.

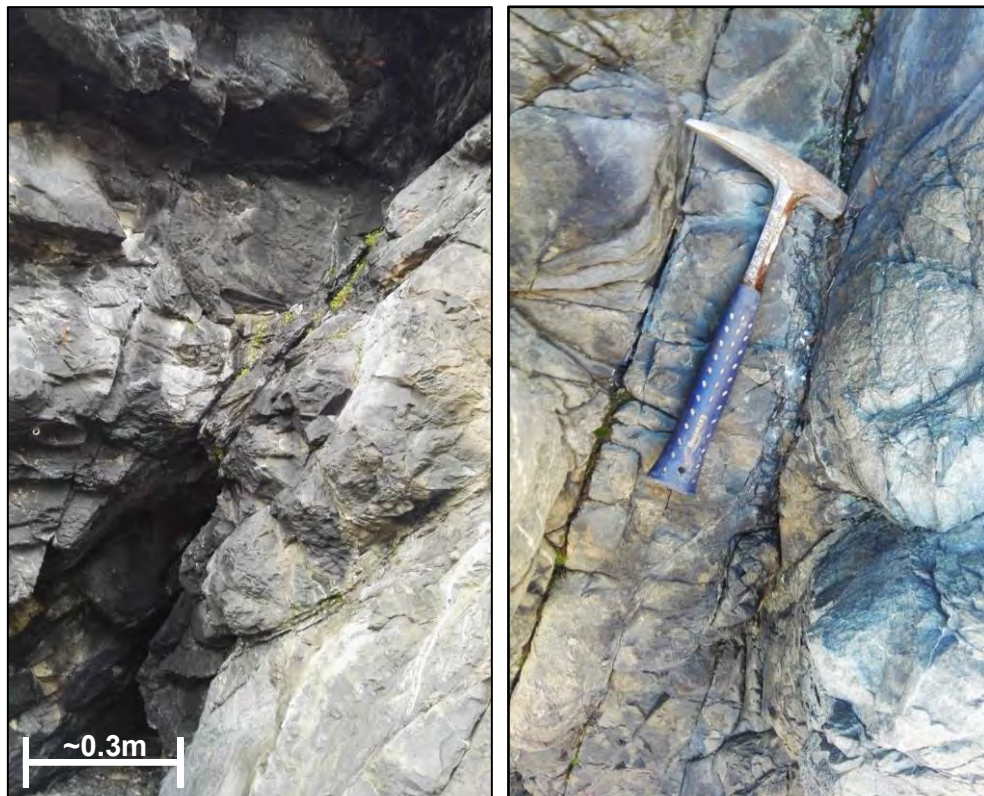
Figure 3.44: Photograph displaying the Bedding (Left) and shearing (Right) and Wairaka point. Geological hammer, ~0.3 m for scale.

Approximately 70% of defects are gapped and or clean (Figure 3.44). This is likely in response to weathering and erosion associated with coastal location of the site. Where there is infill material recorded it is mostly crackle or complete surrounded by a sand matrix. Rock fragments are mostly moderately weathered and strong to very strong.

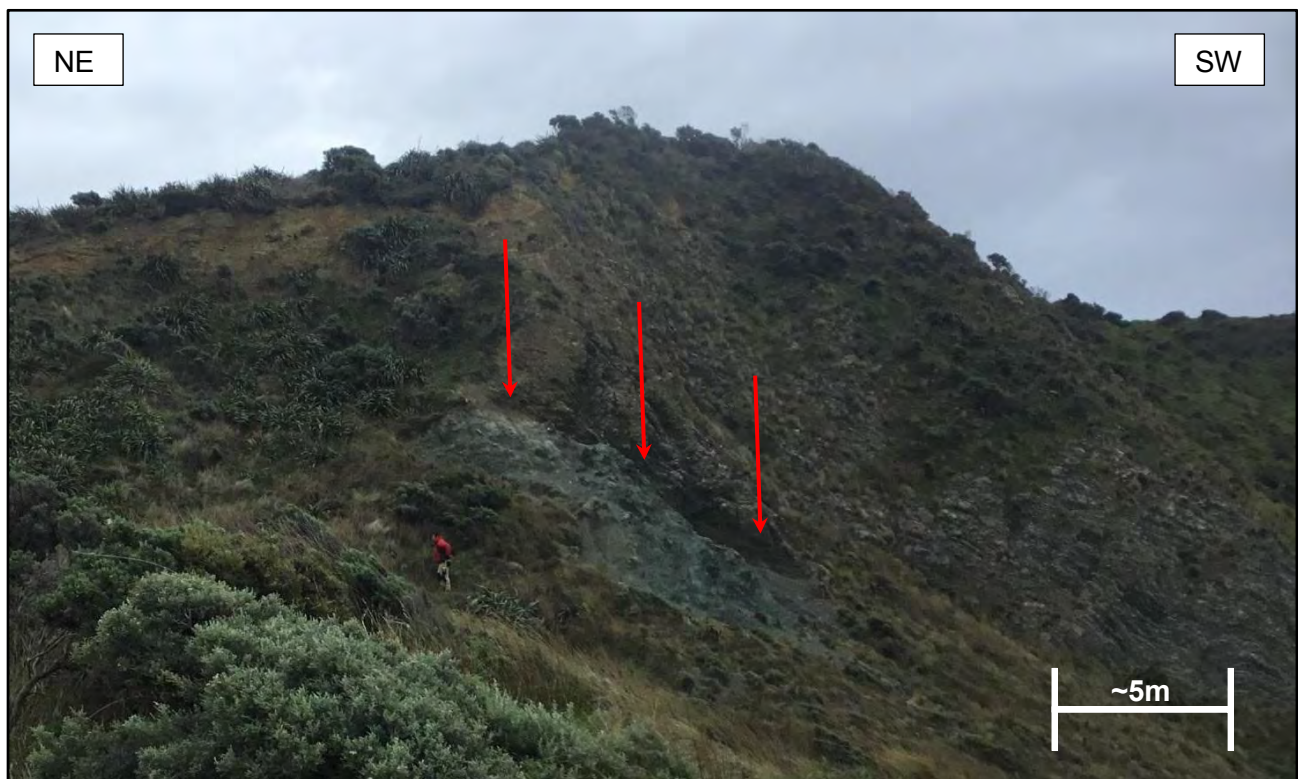
Figure 3.50: Fault trace observed close to the study area.

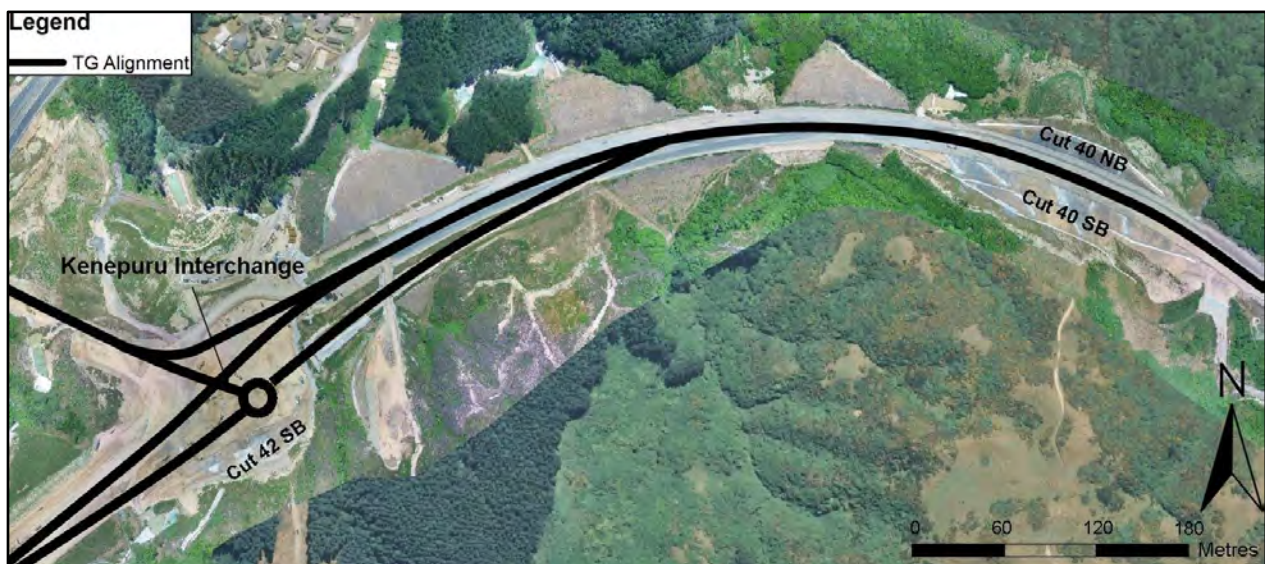
Figure 4.3: Map showing the location of key cuts in the Transmission Gully South site. Imagery sourced from the Transmission Gully GIS Database (2019). See Figure 4.1 for location of this site.

Domain U is bounded by a northeast trending fault to the west and by changes in bedding orientation in the east (Appendix H.5 and H.6). Faulting and shearing from high angle cross faults appear to be the main control on structure in this domain. There are two cuts located within the extents of this domain that obtain borehole data, C40.02 North and South bound (Figure 4.3). The alignment is oriented around a bearing of 100° at this location.

This area obtains only one faulted boundary in the east, which is shared with Domain U (Appendix H.5 and H.6). The Western boundary is not drawn on the map and its unknown how far along the Transmission Gully alignment it extends. The main influence controlling structure appears to be the faulting and shearing of the high angle cross faults. A number of cuts are located within this vast area however only two boreholes with televiewer data are present. These boreholes are located closest to largest cut in this area, C42.01 south bound (Figure 4.3). The alignment in this area trends approximately bearing 070°.

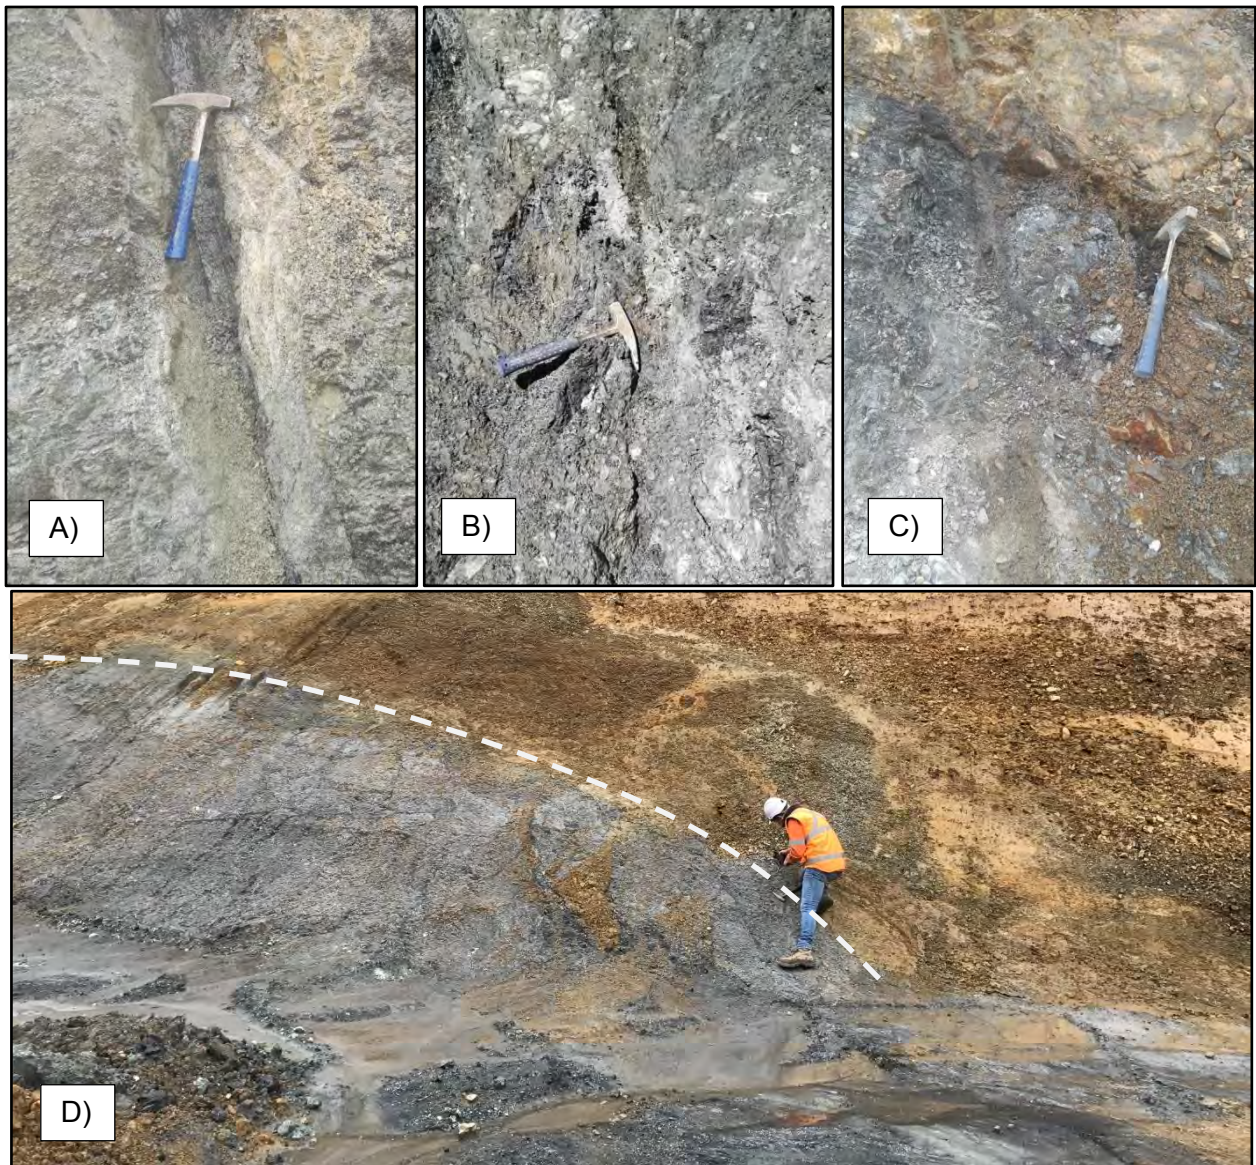
Figure 5.42: Typical rock mass type 8 material. Containing gouge and brecciated material. A) Horokiwi Quarry South outcrop; B) Kapiti Quarry outcrop 1; C) Transmission Gully South outcrop 2a; D) Transmission Gully North Ohariu Fault trace and the related gouge and breccia material.

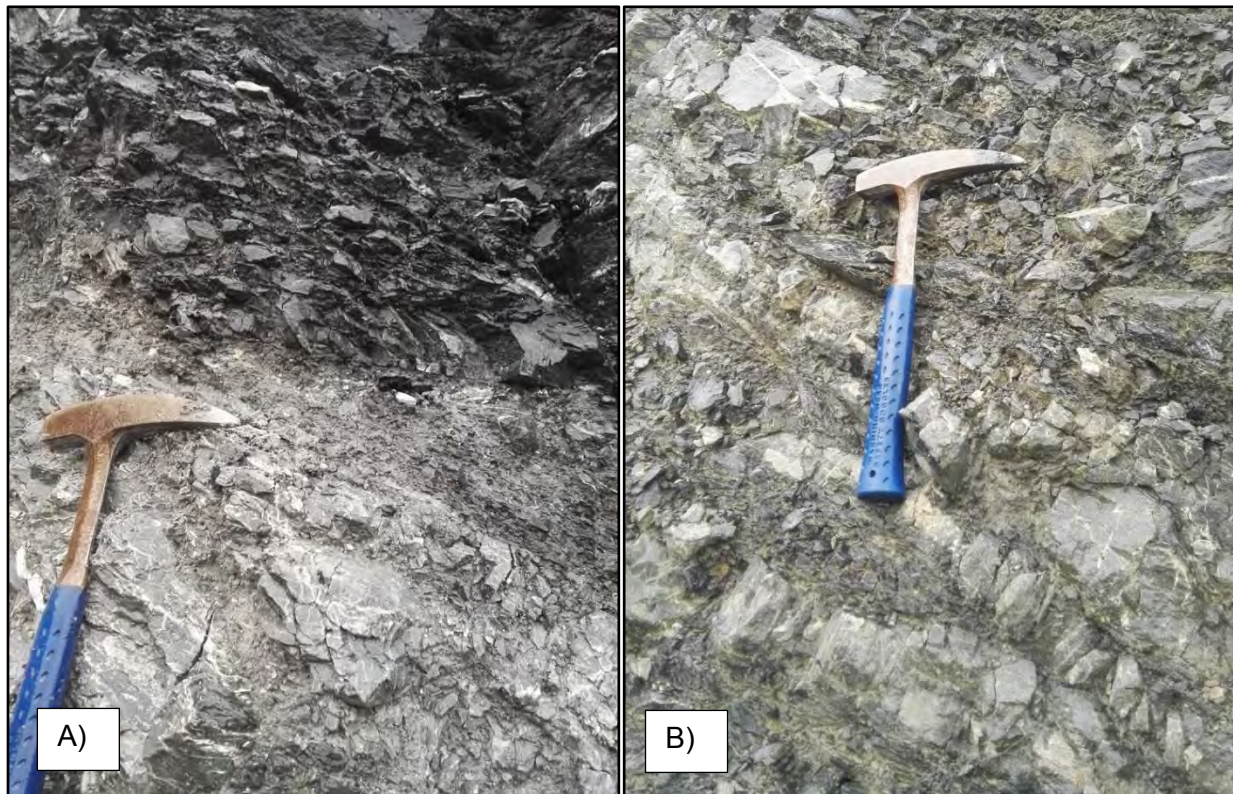
Figure 5.44: Fragmented and heavily sheared rock mass typical of Type 2. A) Kapiti Quarry outcrop 3; B) Kapiti Quarry outcrop 2.

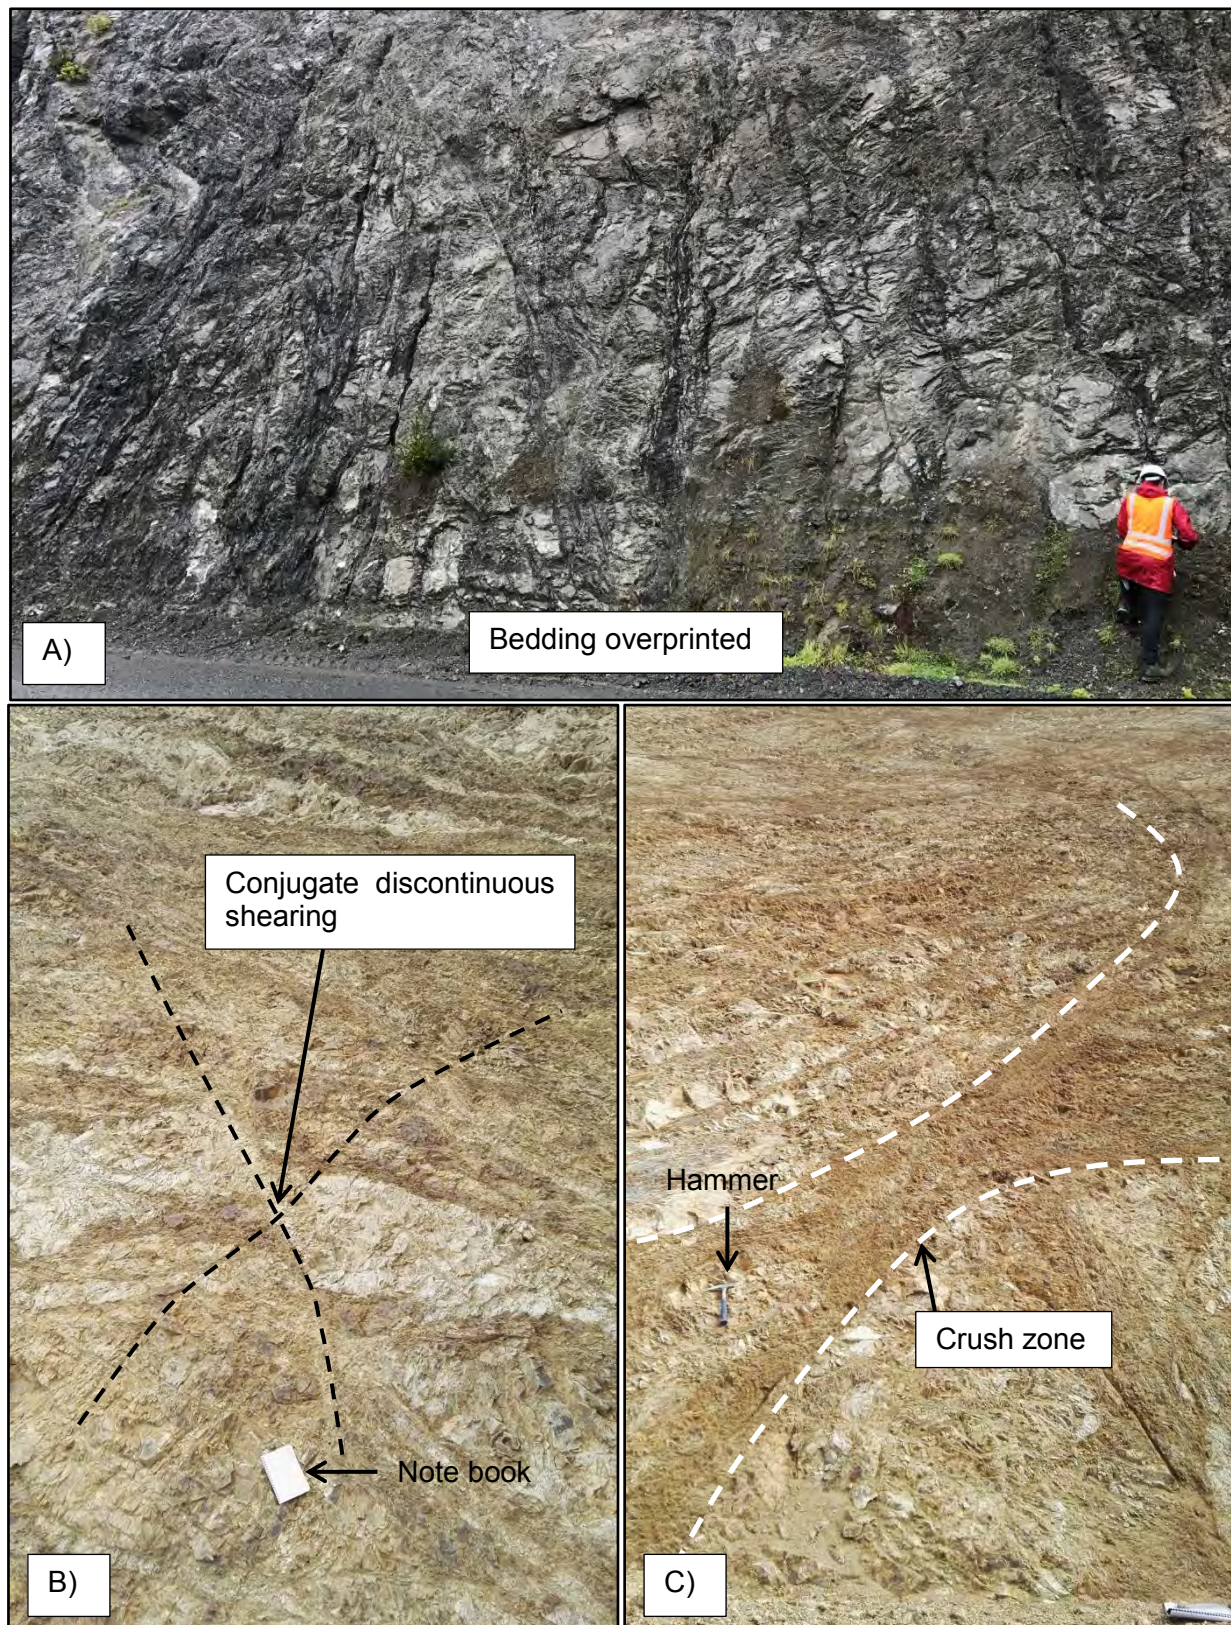
Figure 5.45: Typical rock mass type 3. A) Horokiwi Quarry south outcrop displaying overprinted bedding; B) Discontinuous shearing and cross-cutting systematic shears in Transmission Gully North outcrop 2a; C) Continuous Crush zone in Transmission Gully North outcrop 1c.

Type 3 is generally characterised by a high degree of deformation and is located close to major fault traces (Figure 5.45). It represents a more sandstone rich version of rock type 2. Sandstone and mudstone beds are generally medium to thinly bedded and commonly overprinted (Figure 5.45.a). Frequent occurrences of thick sandstone beds are rare. Bedding can be persistent but is commonly gently wavy and discontinuous. Generally, jointing is closely spaced, randomly orientated and discrete. Closely spaced systematic and sub-systematic shears are in approximately equal portions and tend to terminate against other defects (Figure 5.45.b). Few defects are persistent (> 10 m) with those that are tending to be shear zones, crush zones and faults (Figure 5.45.c). The continuous and persistent features are what are thought to govern global slope stability. Infilling is still dominated by rock clasts (<75 %) and obtains a slightly higher sand proportion in comparison to rock type 2, hence, the infilling material may obtain a slight plasticity. Defects are generally more planar than what is observed in rock type 2.

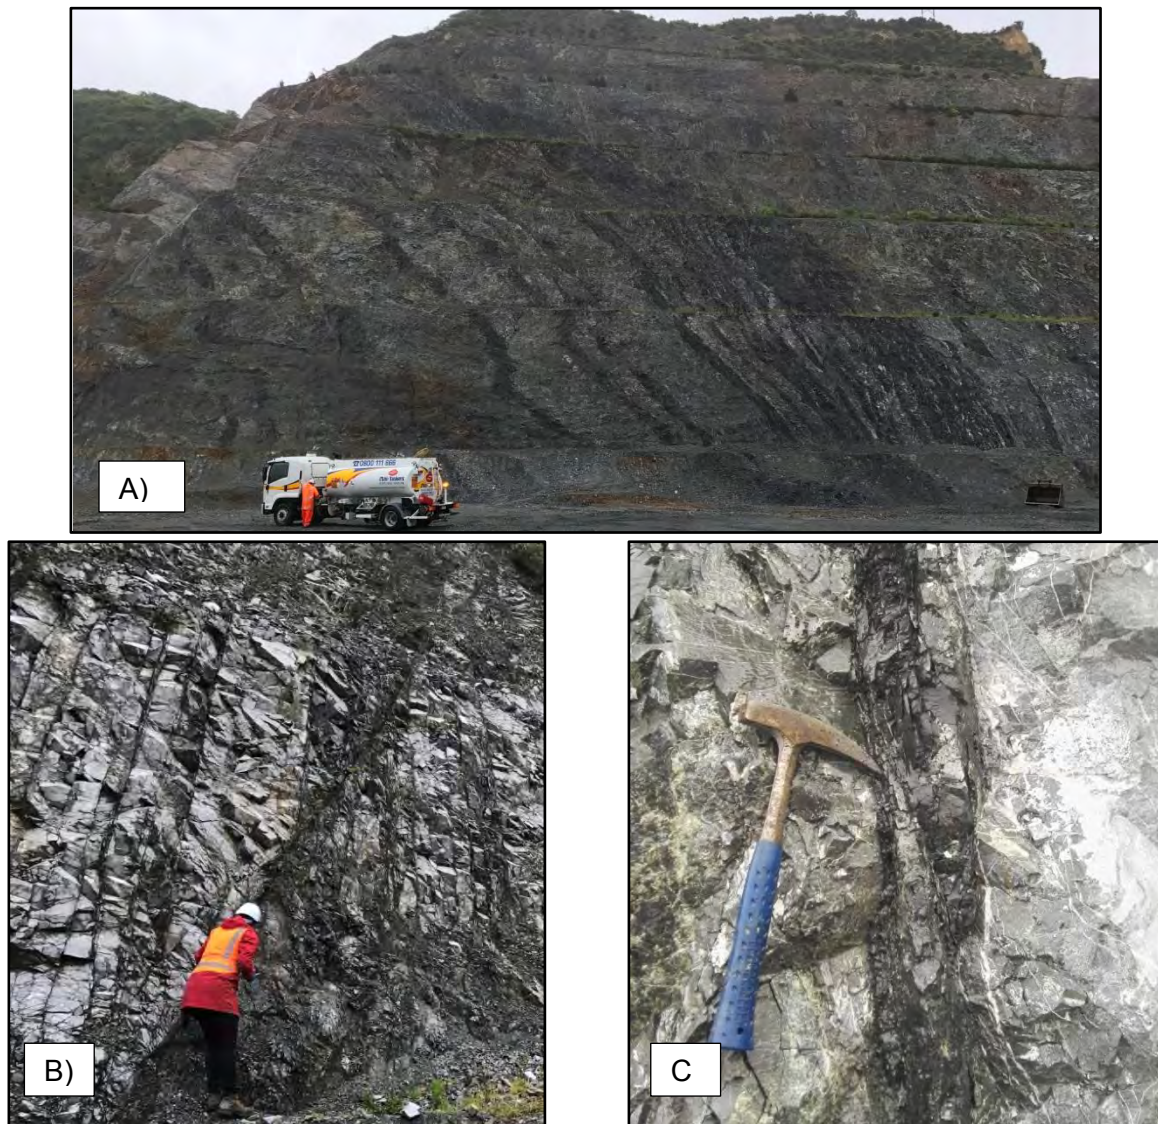
Figure 5.47: Persistent (>20 m) bedding and shearing structures typical of rock mass type 5. A) Continuous bedding disrupted by folding in Horokiwi Quarry West outcrop; B) shearing forming conjugate to bedding in the Horokiwi Quarry North outcrop; C) bedding plane shearing in mudstone from Horokiwi Quarry West outcrop.
